Covina Town Center Historic Resource Survey

Historic Preservation Partners
Spring 2007

for the City of Covina

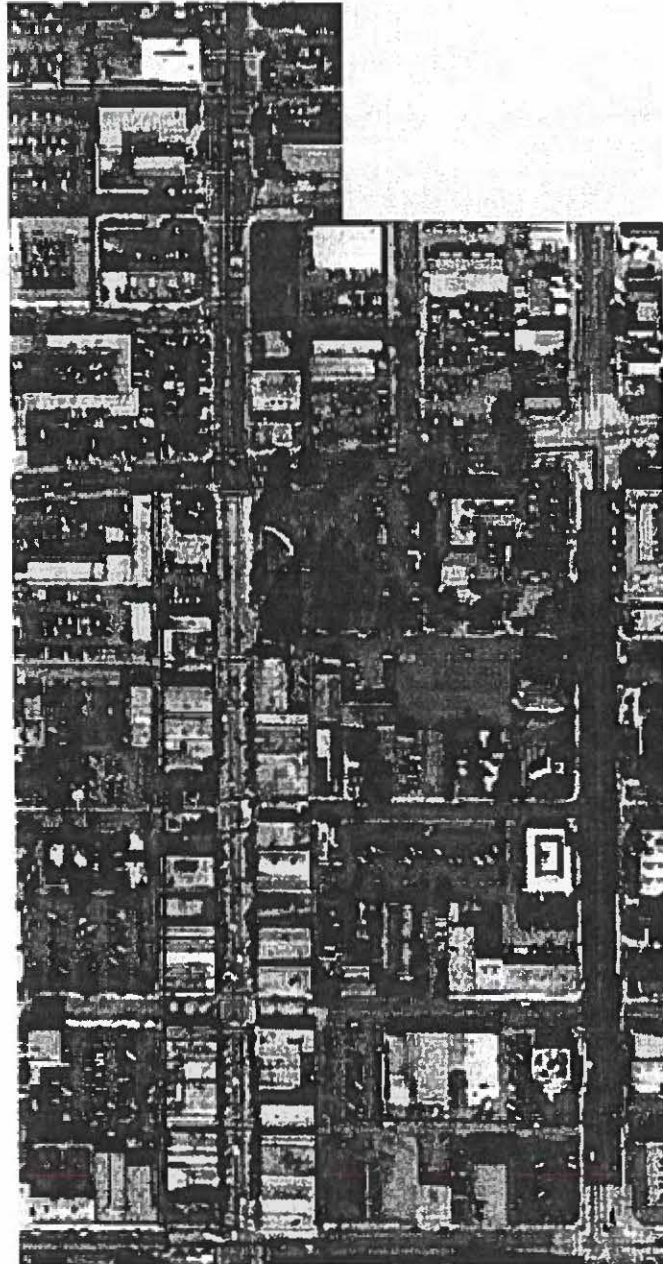
downtown dist. map.

Downtown Commercial Historic
District

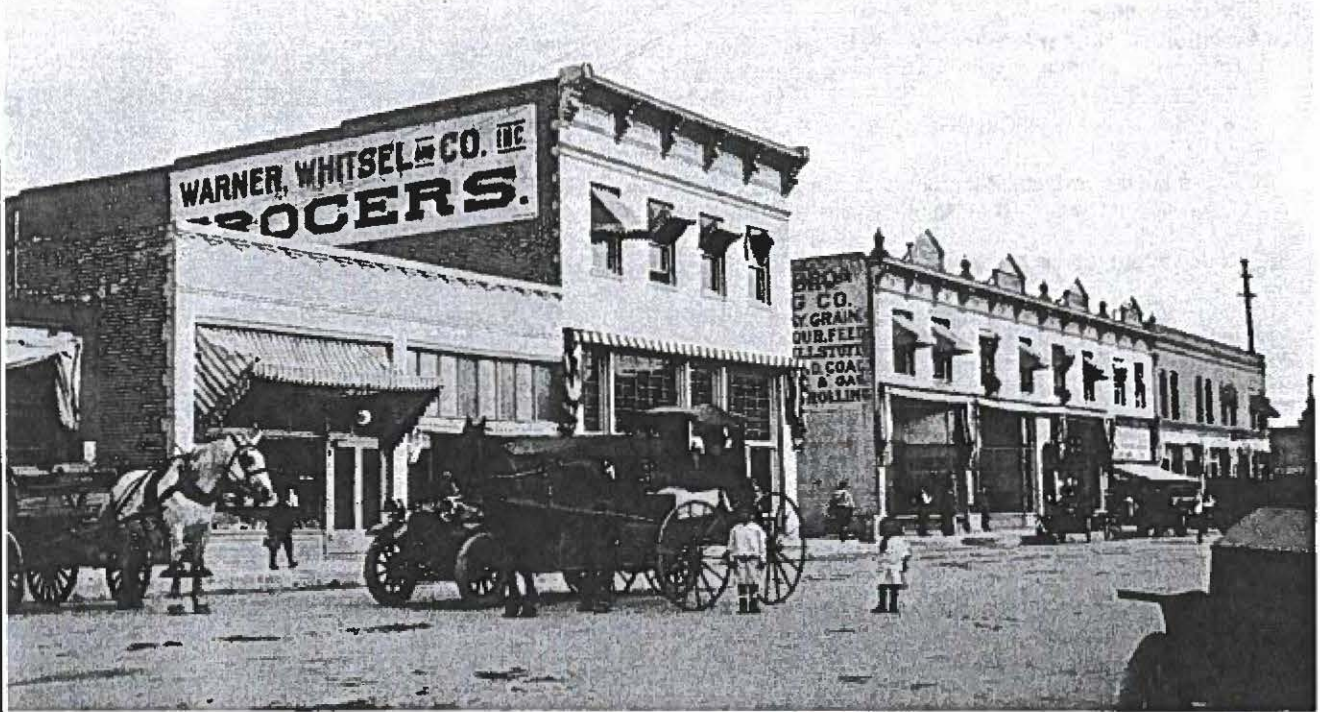
Historic streetscape photograph showing original appearance of 114-118 N. Citrus Ave. (It is the building with the elaborate parapets).

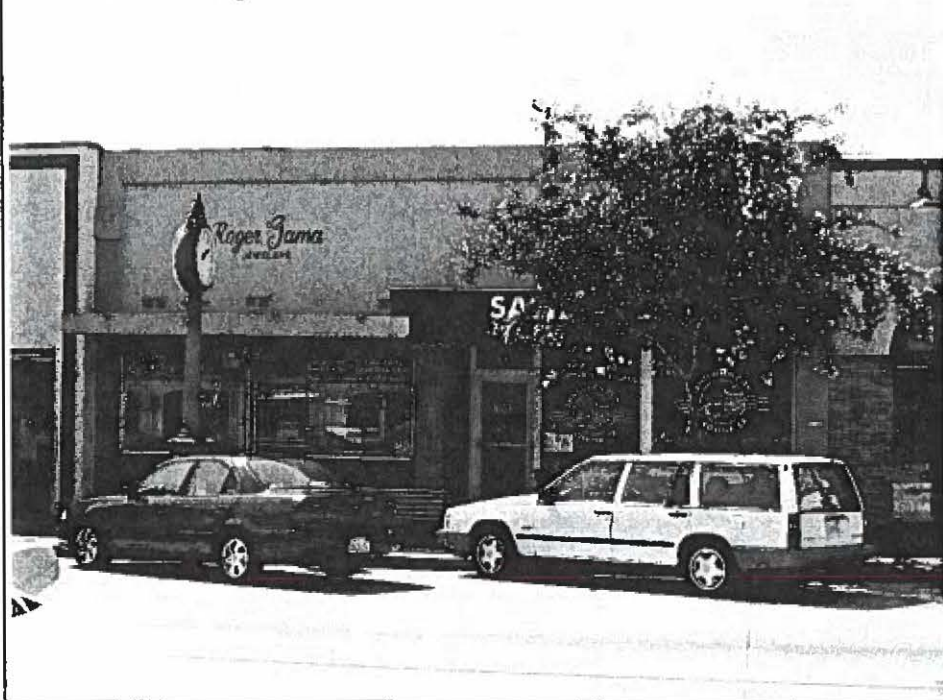
P5a. Photo or Drawing

Potential contributor to Covina's potential Downtown Historic District. 115 North Citrus Avenue is a one part commercial block building. The estimated construction date on the building is 1920. 115 N. Citrus is a rectangular shaped masonry building in good condition with a stuccoed façade (alteration). The building has had alterations made to the façade including: new windows on both the first and second floors, an awning added above the first floor elevation and new brick and stucco work which covers the original masonry façade. Despite these alterations, this building still maintains its ability to convey its historic feel and is a contributor to Covina's downtown development history.

P5b. Description of Photo:
 View W (9/18/06)

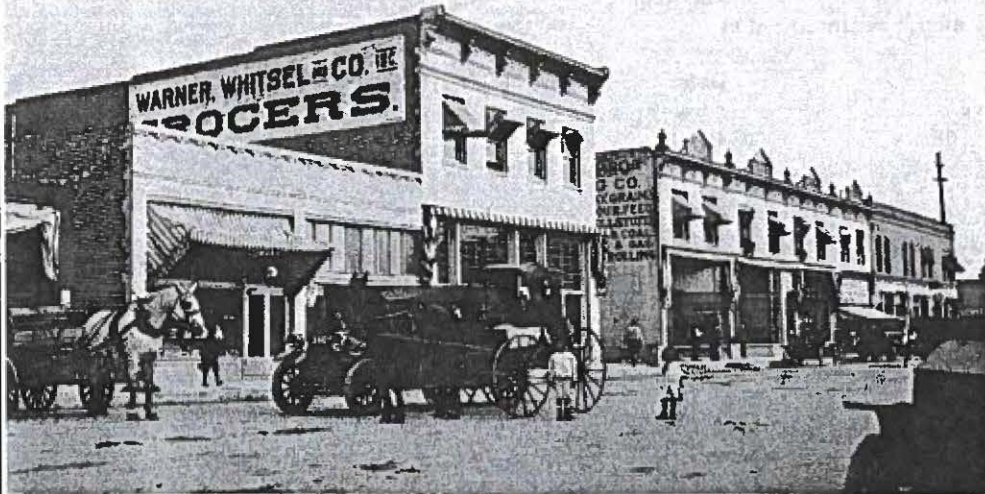
View of Citrus Avenue, including 122 N. Citrus Ave. (historic photograph)

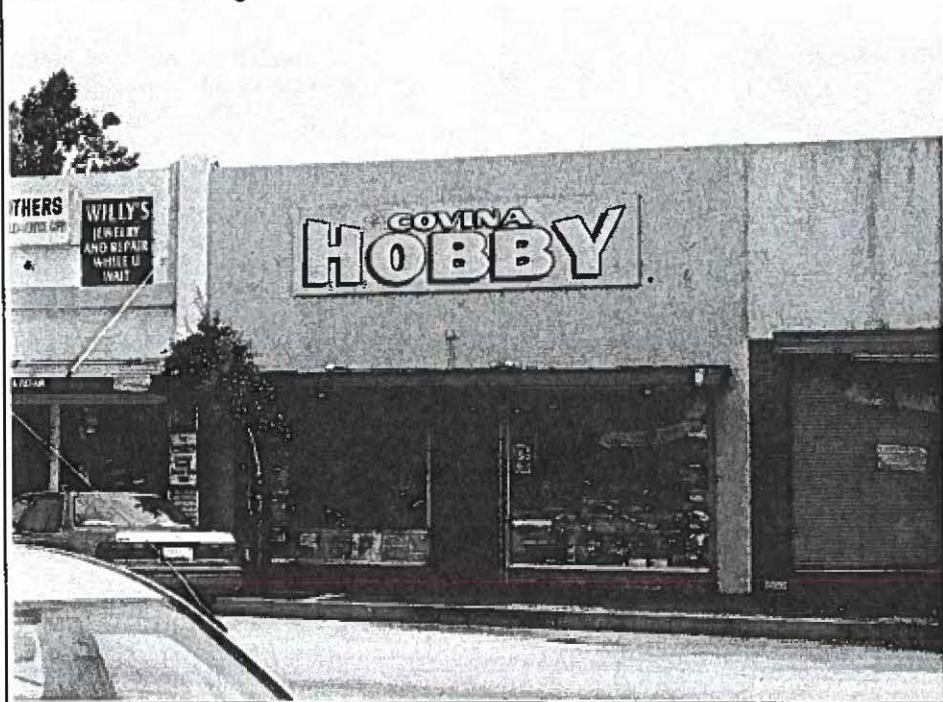
P5a. Photo or Drawing

Potential contributor to Covina's Potential Downtown Historic District. 140 North Citrus Avenue is a one part commercial block building that adjoins its historic neighbor 134 North Citrus. AIN data was unable to be obtained on 140 - however this information was found for the property located at 134 N. Citrus. Because the buildings are linked together it is likely that they were built at the same time. 134 N. Citrus was built in 1920 and is 1,976sq. ft. 140 North Citrus appears to be the same.

140 North Citrus is a masonry building that has had stucco applied to its original brick façade. Other alterations include removal of existing parapet and new signage and new large display windows and glass front door. The building is in good condition. Though the building is not to be individually nominated, due to these alterations, as a grouping, the masonry buildings along the Eastside of Citrus are still able to convey their historic feel and setting due to their concentration, remaining structural material and original sizing.

P5b. Description of Photo:
 View E (10/1/06)

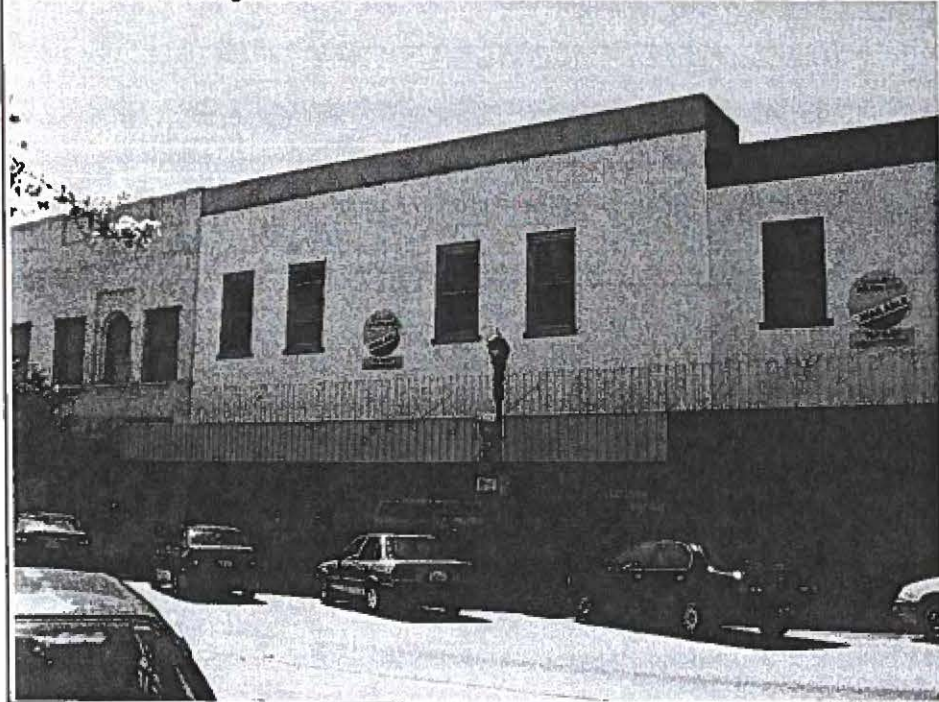
P5a. Photo or Drawing

Potential contributor to Covina's potential Downtown Historic District. 217 North Citrus Avenue is a two part commercial block building located on the Eastside of Citrus Avenue. AIN data was not available on this building, however it appears to have been built circa 1900. 217 N. Citrus is a rectangular shaped masonry building (that has been painted) with original second story windows. Building permits on this building indicate that the aluminum marquee was added and the first floor display windows and front door were replaced in 1961. In addition an interior plaster ceiling was replaced in 1994. Despite these alterations, the building is still eligible to be a contributor to the potential Downtown Historic District due to its ability to convey its historic feel and sense of place. The building is in good condition and retains much of its original structural building materials.

P5b. Description of Photo:
 View W (9/18/06)

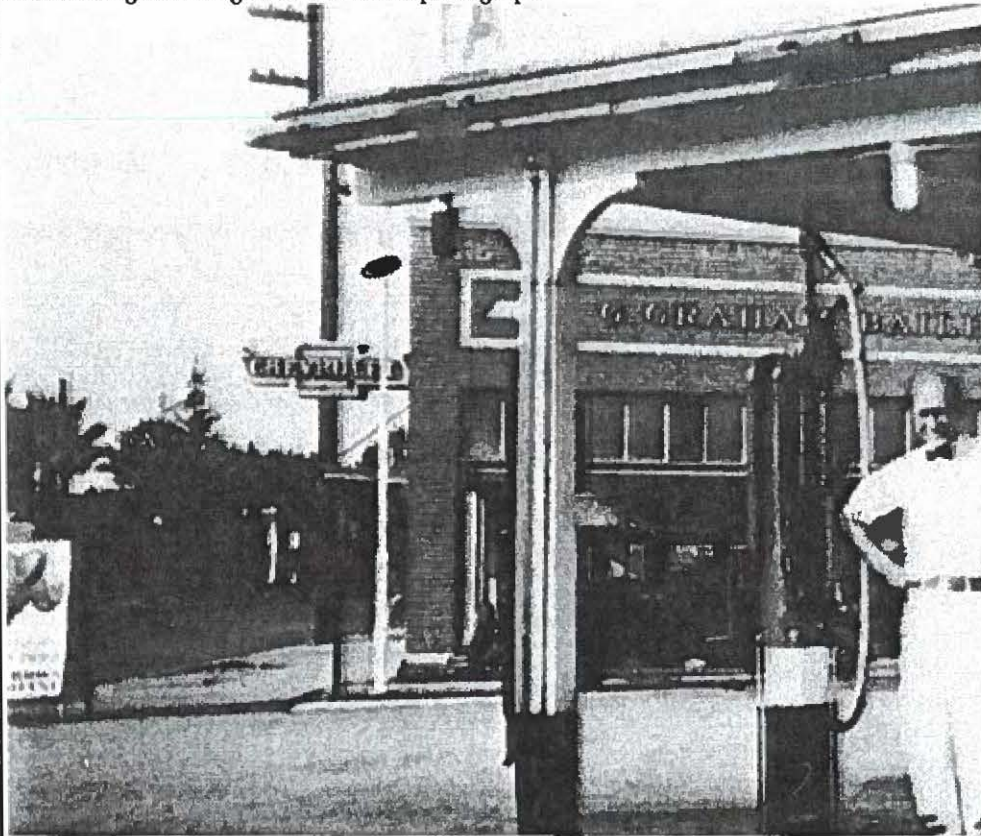
Current Chevrolet sign

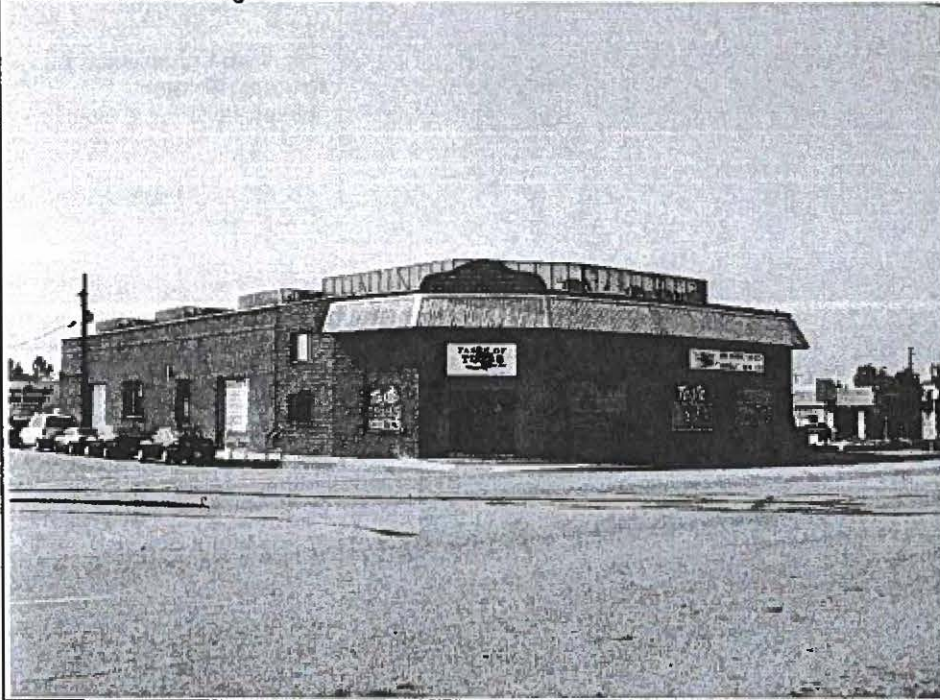
P5a. Photo or Drawing

545 N. Citrus is a one part commercial block constructed of brick and concrete block. The original portion of the building (visible on the rear and side façades) was constructed in 1929. As a secondary alteration the building has a non-historic mission revival parapet. The alterations to the façade of the building appear to have occurred after the initial construction phase and the building appears to be in good physical condition.

P5b. Description of Photo:
View NW (9/18/06)

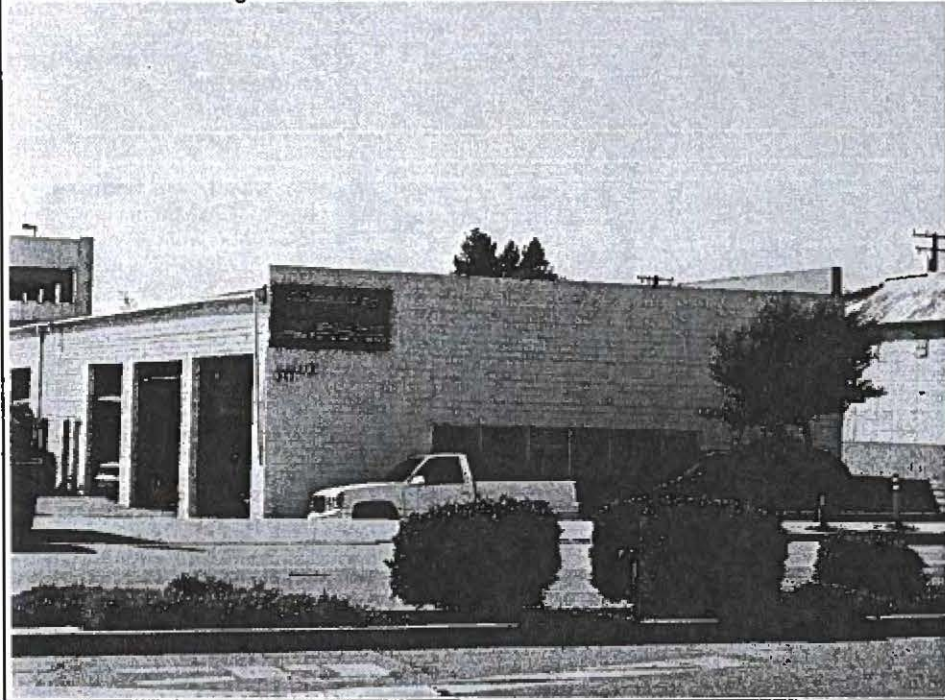
P5a. Photo or Drawing

579-583 N. Citrus is a one part commercial block that was purpose built to serve as an auto repair shop. It is presently the site of Chassis by Aaron Iha. The building is located in the northern portion of the survey area. The building is located just north of Citrus and Front St. in a commercial/industrial area and appears to be in good condition.

P5b. Description of Photo:
View NW (9/18/06)

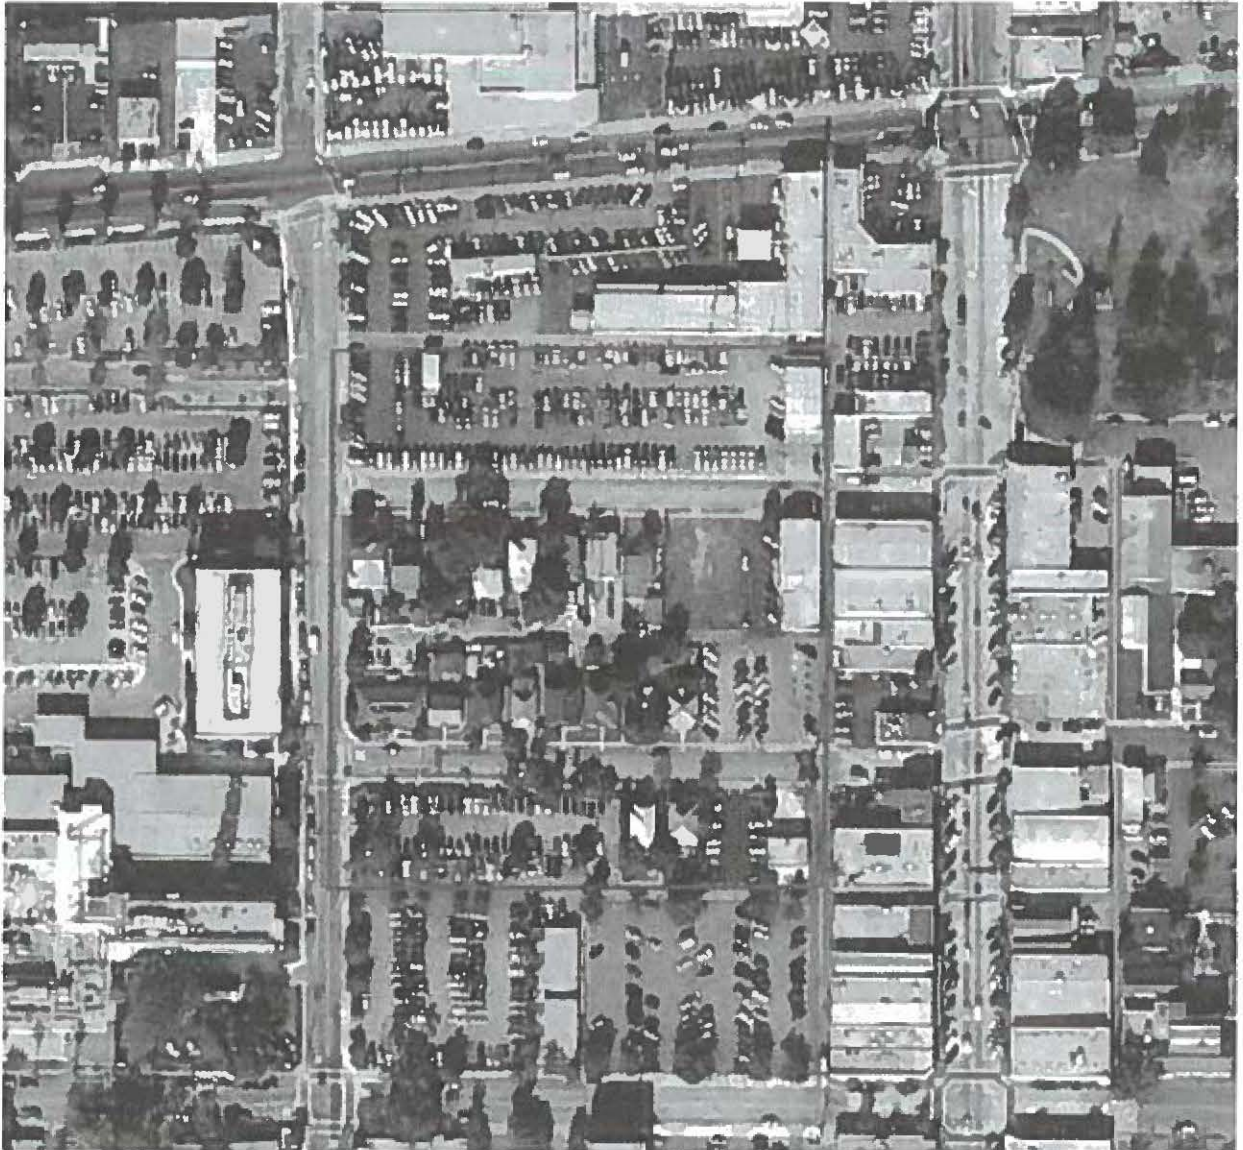
Page _____ of _____ *Resource Name or # (Assigned by recorder)
*Map Name: Cottage District *Scale: 1:2300 *Date of map: 2/11/07

Cottage Drive Historic District
Contributors (13)

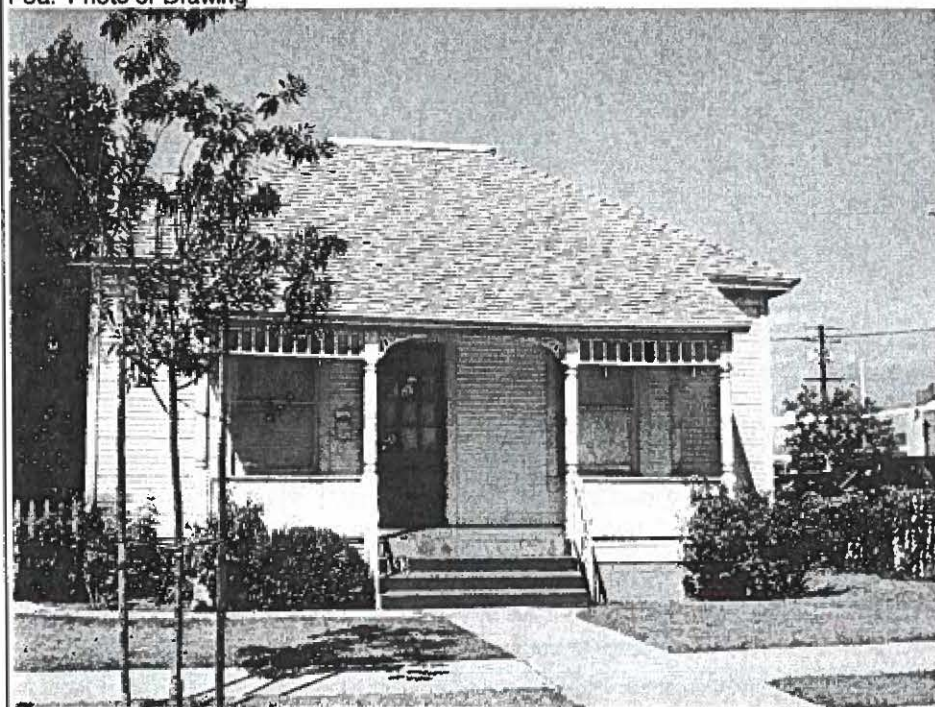
P5a. Photo or Drawing

The house located at 133 W. Cottage Drive is a contributor to the potential Cottage Street Historic District. The cottage, constructed circa 1900, exemplifies the Folk Victorian style with its simple ornamentation and form. The clapboard clad house has a square plan and hipped roof. The house's character-defining features are the central front porch with spindlework detailing, hipped roof, clapboard exterior, symmetrical fenestration, and turned support columns of the front porch. The house sits close to the street on a raised foundation in the residential neighborhood adjacent to Covina's historic downtown. The property is listed with the County of Los Angeles as being a 2 bedroom, 1 bath single-family residence with 976 square feet of interior space. The house appears to have had little exterior alteration, with the exception of a small stucco-clad shed addition to the rear of the structure.

P5b. Description of Photo:
View N (10/2/06)

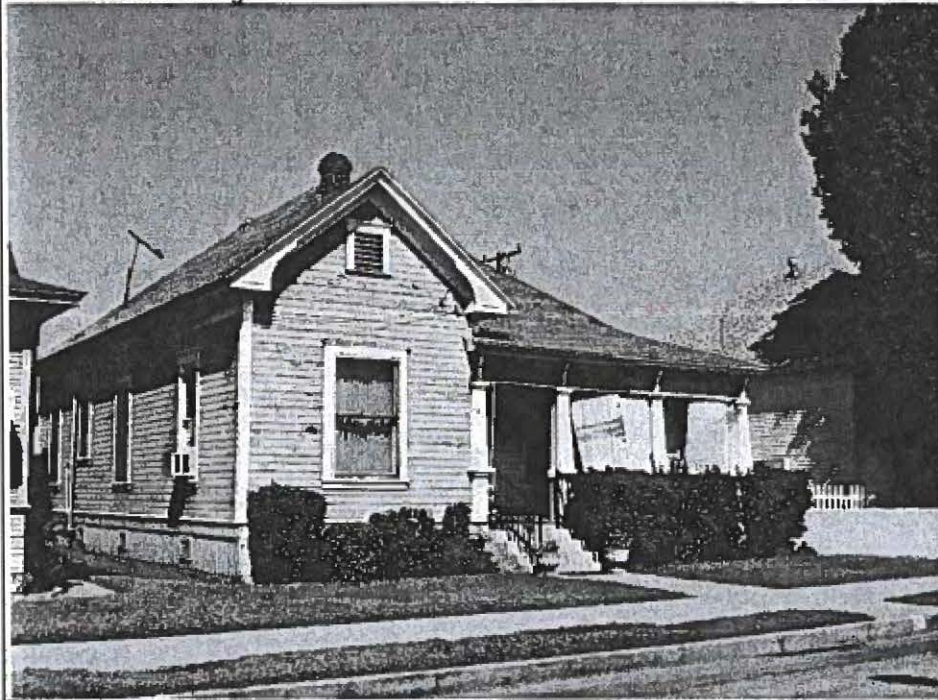
P5a. Photo or Drawing

The house located at 145 W. Cottage Drive is a contributor to the potential Cottage Street Historic District. The cottage, constructed in 1902, exemplifies the Folk Victorian style with its gable front and wing shape, bracketed eaves, and simple ornamentation. The house's character-defining features are the front porch, hipped roof, clapboard exterior, asymmetrical fenestration, and wood support columns of the front porch. The house sits close to the street on a raised foundation in the residential neighborhood adjacent to Covina's historic downtown. The property is listed with the County of Los Angeles as being a 2 bedroom, 1 bath single-family residence with 1,314 square feet of interior space. The house appears to have had little exterior alteration, with the exception of metal railings on the front porch, and is in good condition. An additional element of the property is the single car corrugated metal garage.

P5b. Description of Photo:
 View NE (10/2/06)

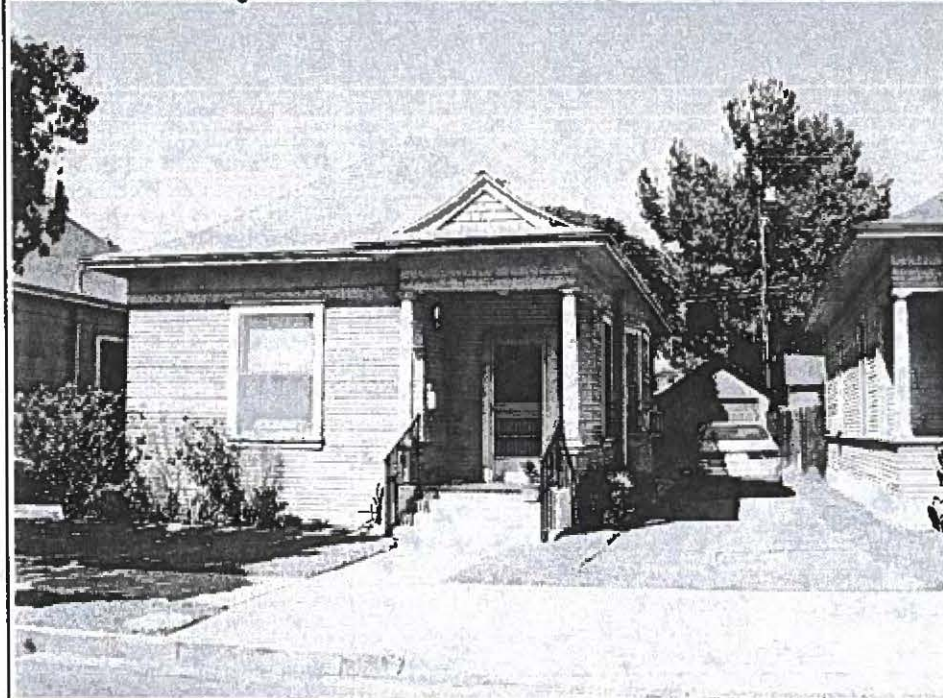
P5a. Photo or Drawing

The house located at 153 W. Cottage Drive is a contributor to the potential Cottage Street Historic District. The cottage, constructed in 1901, exemplifies the Folk Victorian style with its simple ornamentation. The clapboard clad house has a square plan and hipped roof. The house's character-defining features are the small corner front porch with plain shingles, hipped roof, clapboard exterior, asymmetrical fenestration, and classical support columns of the front porch. The house sits close to the street on a raised foundation in the residential neighborhood adjacent to Covina's historic downtown. The property is listed with the County of Los Angeles as being a 2 bedroom, 1 bath single-family residence with 1,042 square feet of interior space. The house appears to have had little exterior alteration, with the exception of metal railings on the front porch, and is in good condition. An additional element of the property is the single car corrugated metal garage.

P5b. Description of Photo:
 View NW (10/2/06)

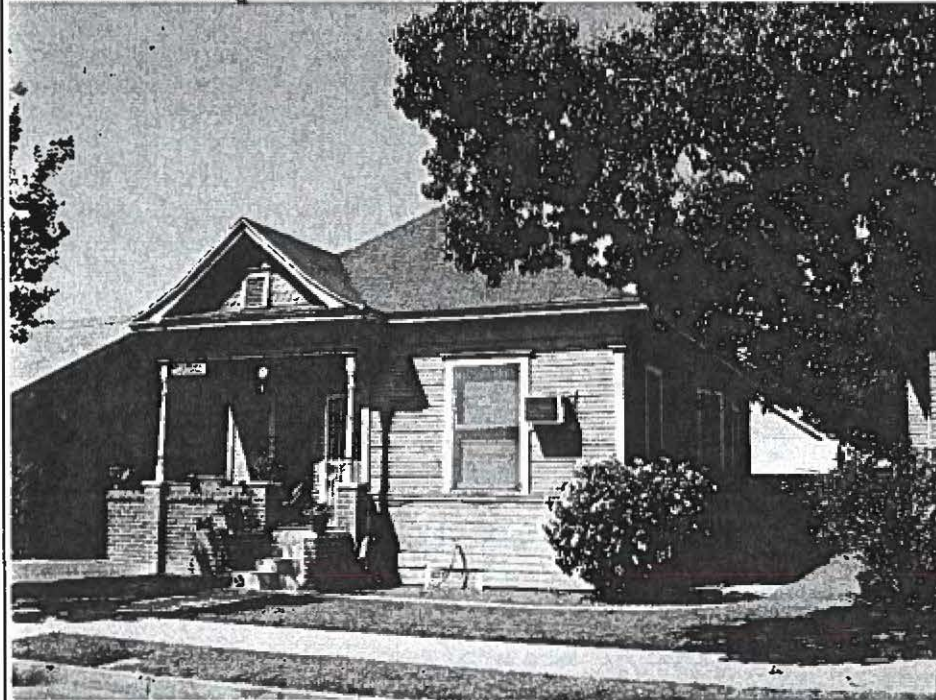
P5a. Photo or Drawing

The house located at 161 W. Cottage Drive is a contributor to the potential Cottage Street Historic District. The cottage, constructed in 1901, exemplifies the Folk Victorian style with its simple ornamentation and form. The clapboard clad house has a square plan and hipped roof. The house's character-defining features are the small corner front porch with fishscale shingle adornment and vent, hipped roof, clapboard exterior, asymmetrical fenestration, and turned support columns of the front porch. The house sits close to the street on a raised foundation in the residential neighborhood adjacent to Covina's historic downtown. The property is listed with the County of Los Angeles as being a 1 bedroom, 1 bath single-family residence with 1,052 square feet of interior space. The house appears to have had little exterior alteration, with the exception of possibly the brick around the front porch, and is in good condition. An additional element of the property is the single car corrugated metal garage.

P5b. Description of Photo:
View NW (10/2/06)

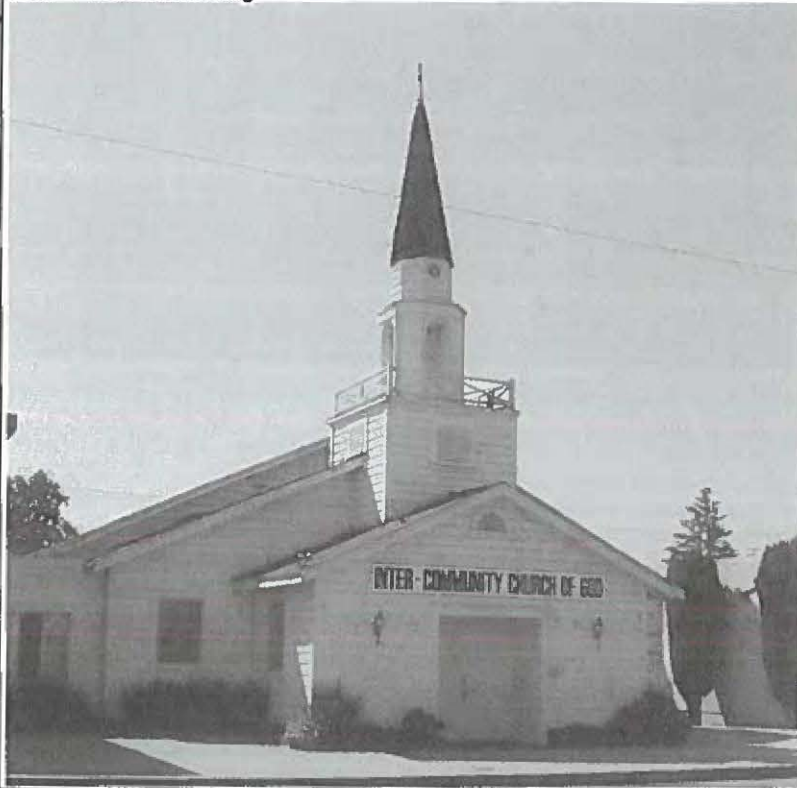
P5a. Photo or Drawing

105 W. Badillo is a small neighborhood church with white clapboard exterior and steeple. The building, constructed in 1932, has 5,151 square feet of interior space (according to the Los Angeles County Assessor). The church is characterized by multiple front facing gable peak roofs and a multi-sided (possibly octagonal) church steeple that projects from a square base that intersects the gable roof. The material of the steeple roof is wood shingle (possibly original). The remainder of the building's roof materials have been replaced with modern asphalt shingle. The church is located on the south side of Badillo in close proximity to Covina's downtown "main street" (Citrus Avenue). The church appears to have had some alterations, including additions. However, these alterations do not hamper its ability to present a quintessential neighborhood ecclesiastical appearance from the street.

P5b. Description of Photo:
View SW (10/2/06)

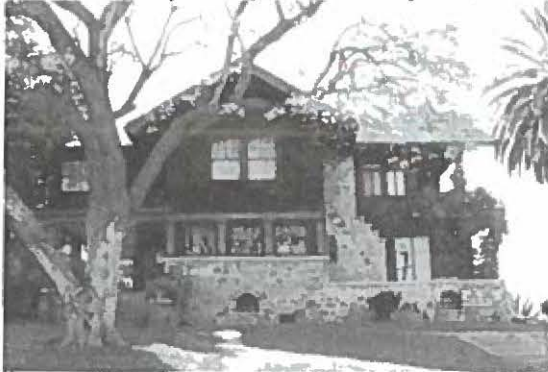
The Holy Trinity Episcopal Church was designed by a prominent Los Angeles architect named Arthur B. Benton. Benton began his career as a draftsman for the Union Pacific Railroad in Omaha Nebraska. After moving to Los Angeles in 1891 he began a partnership with William C. Aiken (1893). During their partnership, Benton designed shingle style houses that featured the use of rusticated stone bases and shingled walls. The house below illustrates many of the same material choices seen on the Holy Trinity Church. (see photo)

Photo: House designed by Arthur B. Benton
(www.historicechopark.org/id106.html)

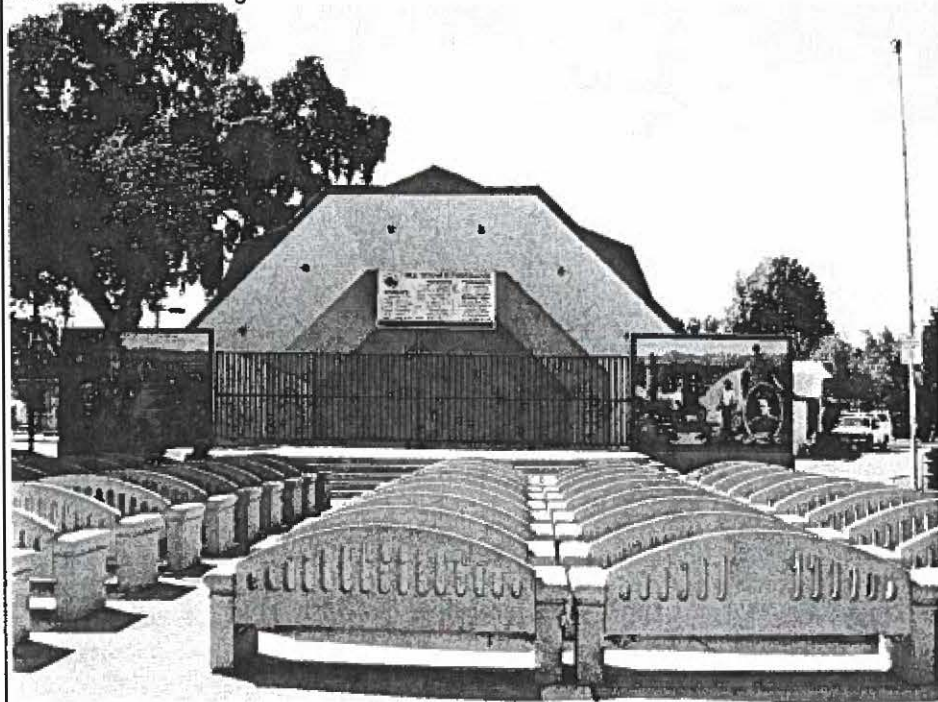
Note: Bandshell Plaque lists: Built in 1963, Expanded – 1986, and refurbished in 1988. Replaced older Bandshell?
 Heritage House is a Craftsman house that was moved to the park and received a new foundation. American Legion Hall is thought to have been built in 1930, according to notations on historic photographs (see continuation sheet).

P5b. Description of Photo:
 View W (10/5/06)

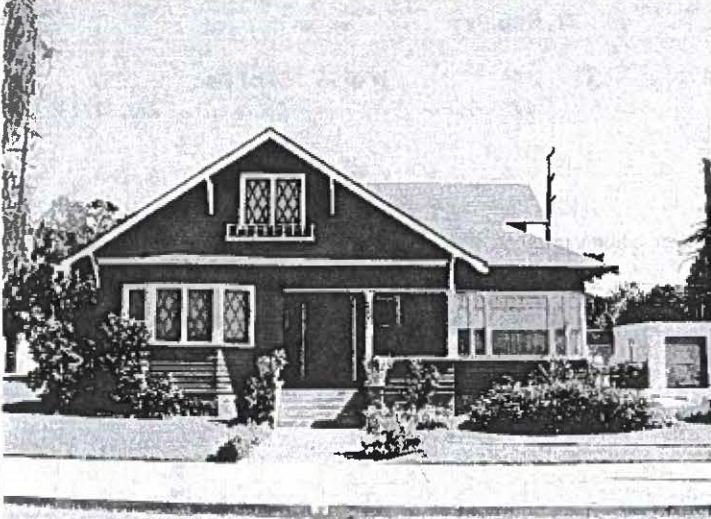
Heritage House (historic home constructed in 1908 by the Nash family and recently moved to the park for use as Historical Society space)

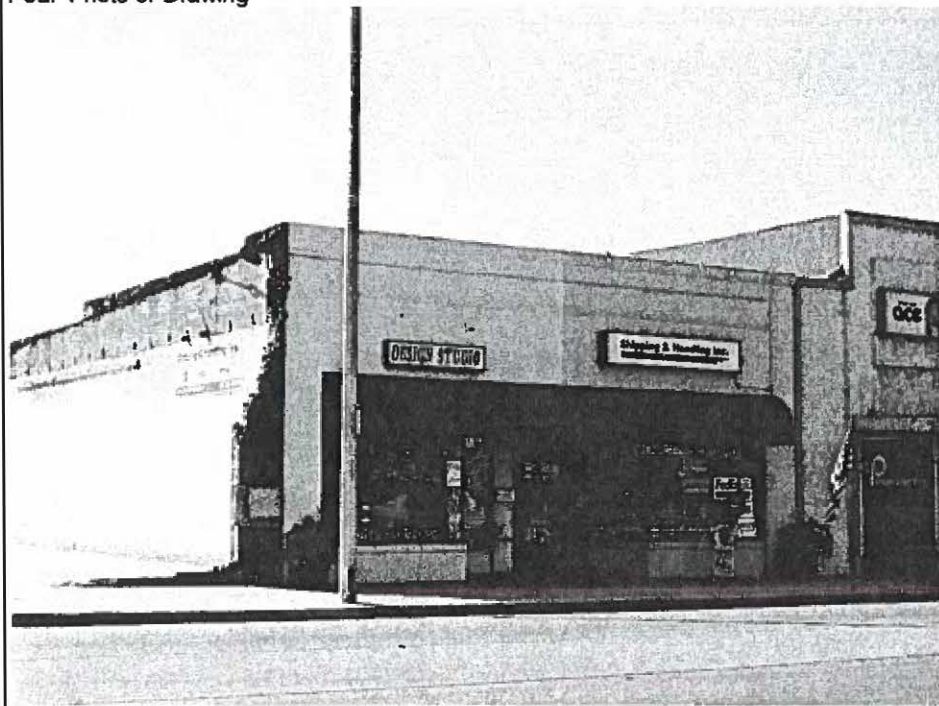
126 E. Badillo St. is a one part commercial block with stucco over brick constructed in 1923, consisting of 3,500 square feet (according to the County Assessor). The building is primarily stucco with large plate glass windows and recessed entry. The character-defining features of this building are the massing and the entry door made of wood. The building sits on the south side of Badillo, just south of Covina's historic downtown core. There are other commercial building in the vicinity. The building appears to be in good condition. Possible alterations observed are the stucco on the exterior and fabric awnings. The crumbled brick of the building that previously sat to the east reveals what the façade of 126 E. Badillo may have looked when it was initially constructed.

P5b. Description of Photo:
 View SW (10/2/06)

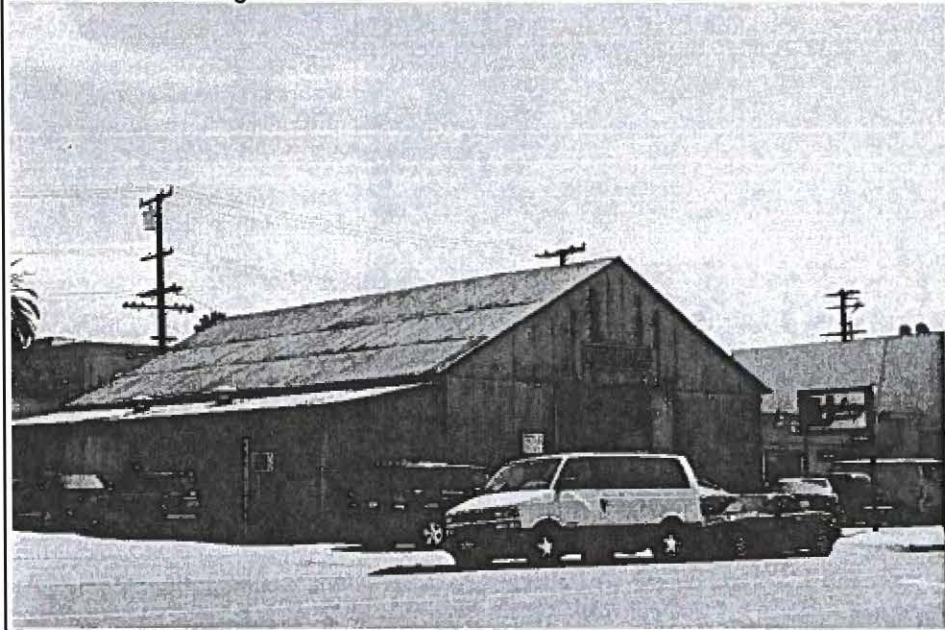
528 N. 2nd Ave. is a corrugated metal industrial building constructed in 1946, consisting of 3,342 square feet (according to the County Assessor). The building has a front facing gable roof sheathed with metal and a large bay with sliding doors on the front facade. The building sits on the east side of 2nd, just south of Front St. in the northern portion of the specific plan area. There are other commercial and industrial buildings in the vicinity. The building appears to be in good condition. There is some rust visible above the bay and on various parts of the structure. The building does not appear to have been altered significantly, with the exception of a shed roofed addition on the north side of the building that may have been an early addition.

P5b. Description of Photo:
View SE (9/28/06)

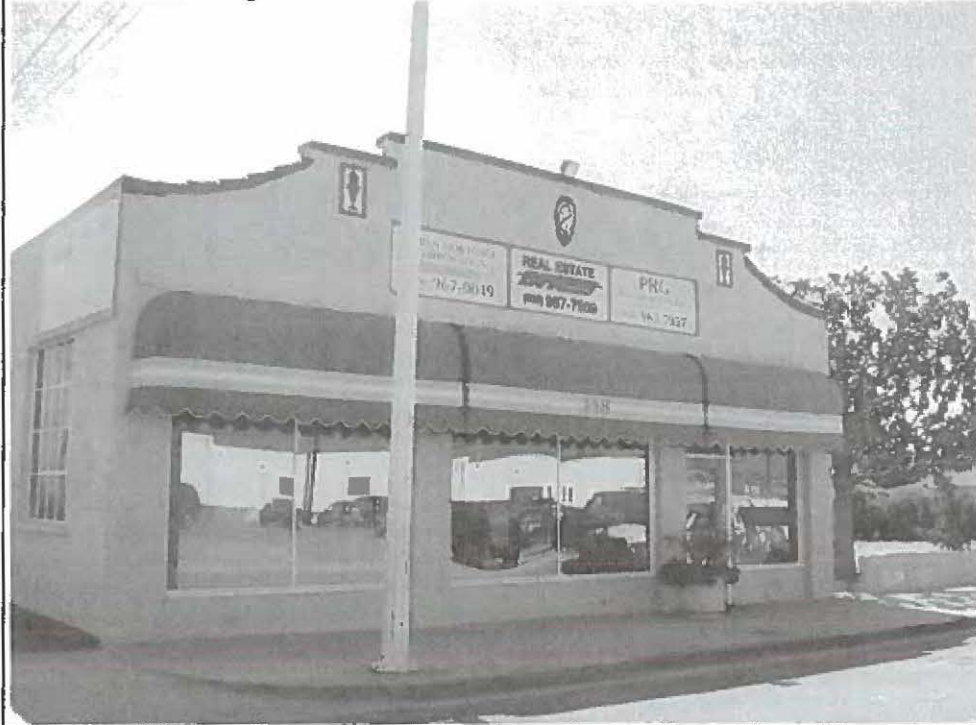
110 W. Orange St. is a one part commercial block with Mission style parapet constructed in 1928, consisting of 4,251 square feet (according to the County Assessor). The building is primarily stucco with large plate glass windows. The character-defining feature of this building is the parapet. The building sits on the south side of Orange, just west of Citrus. There are other commercial building in the vicinity. The building appears to be in good condition. Possible alterations observed are the large glass windows and change of openings, aluminum doors, rough-finish stucco, and fabric awnings.

P5b. Description of Photo:
 View SW (10/2/06)

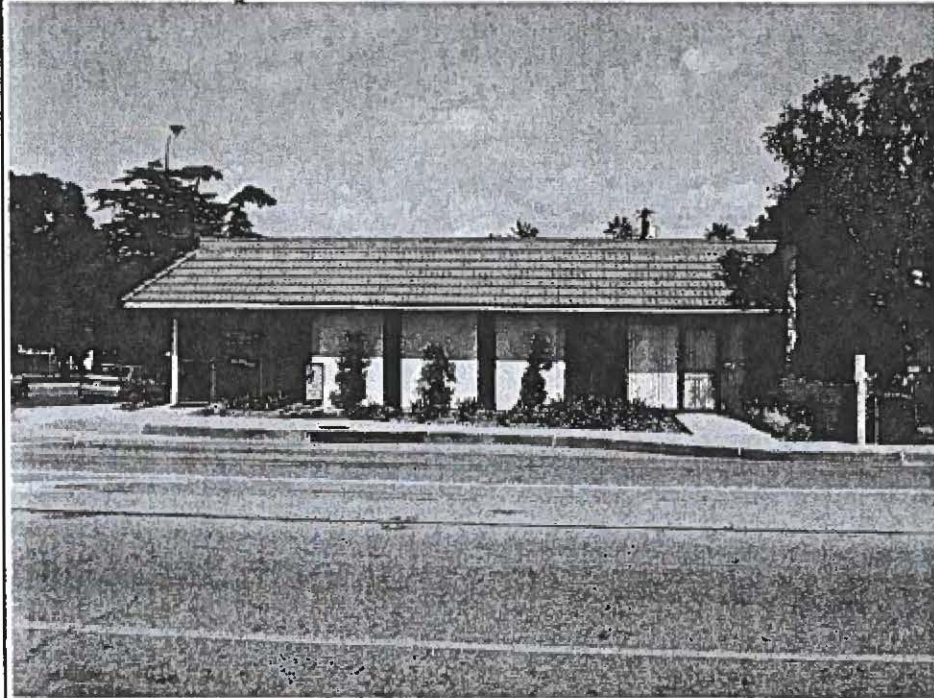
P5a. Photo or Drawing

273-279 W. Badillo St. is a one part commercial block constructed in 1979, consisting of 2,600 square feet (according to the County Assessor). The building is rectangular in plan and has a mansard roof. The building is located adjacent to Covina Park. The building appears to be in fair to good condition.

P5b. Description of Photo:
View N (10/2/06)

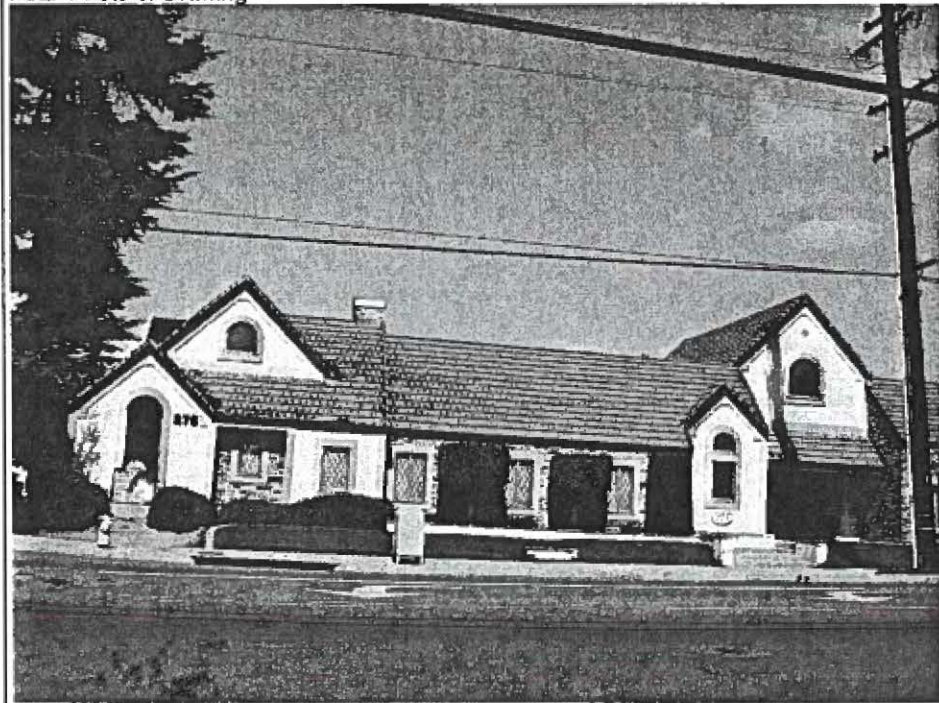
P5a. Photo or Drawing

275 W. San Bernardino Rd. is a one part commercial block constructed in 1984, consisting of 5,881 square feet (according to the County Assessor). The building is Neo-Tudor in style and has front facing gables. The buildings main materials are stucco and brick. There are other commercial building in the vicinity. The building appears to be in good condition.

P5b. Description of Photo:
 View N (10/2/06)

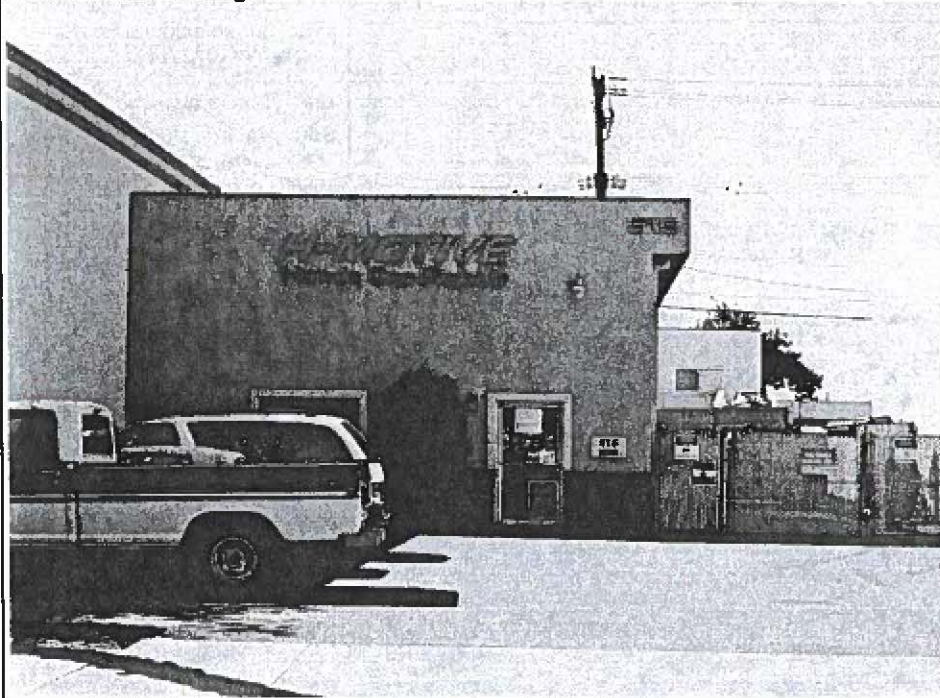
P5a. Photo or Drawing

515 N. Howard Ave. is a one part commercial block constructed in 1965, consisting of 2,400 square feet (according to the County Assessor). The building's main materials are stucco and brick. The front façade of the building is fairly unadorned. This building is located at the northern portion of the specific plan are. The building appears to be in fair to good condition.

P5b. Description of Photo:
 View W (10/2/06)

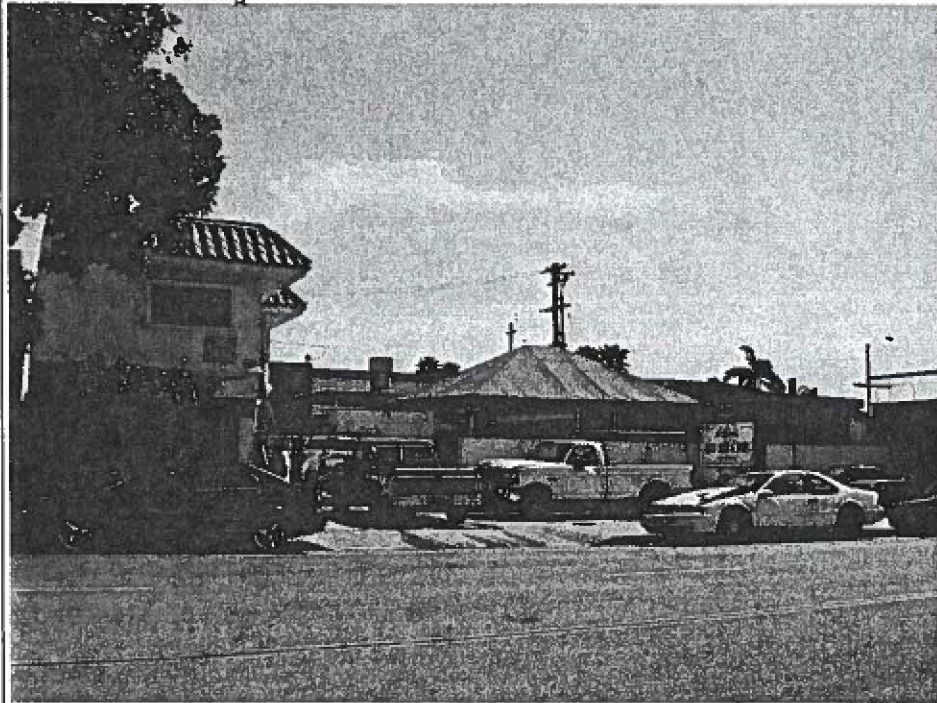
P5a. Photo or Drawing

P5b. Description of Photo:
 View W (9/28/06)

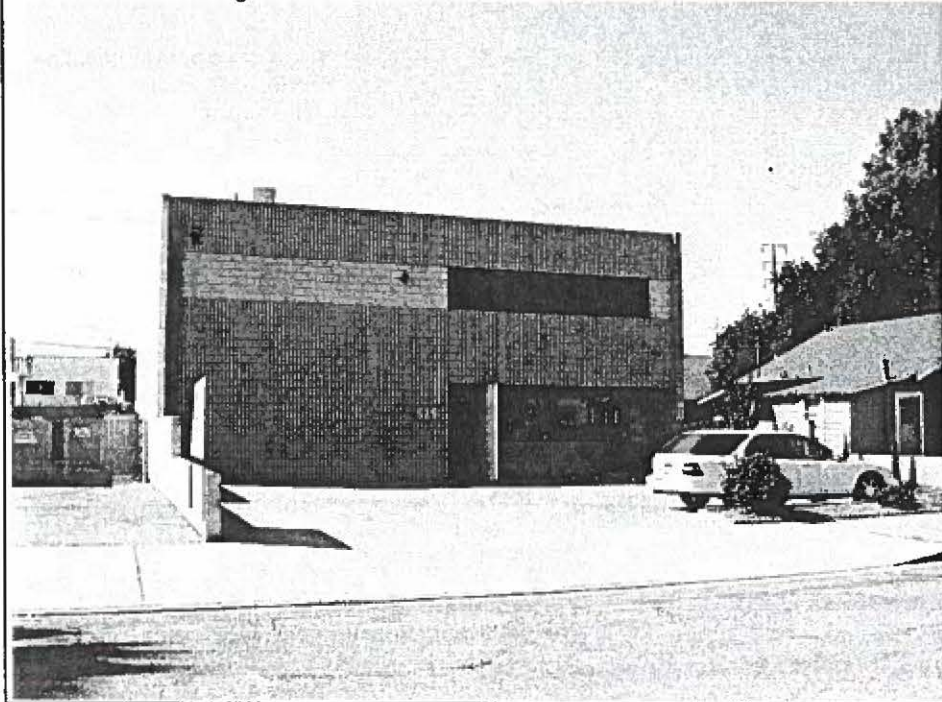
P5a. Photo or Drawing

P5b. Description of Photo:
 View W (10/2/06)

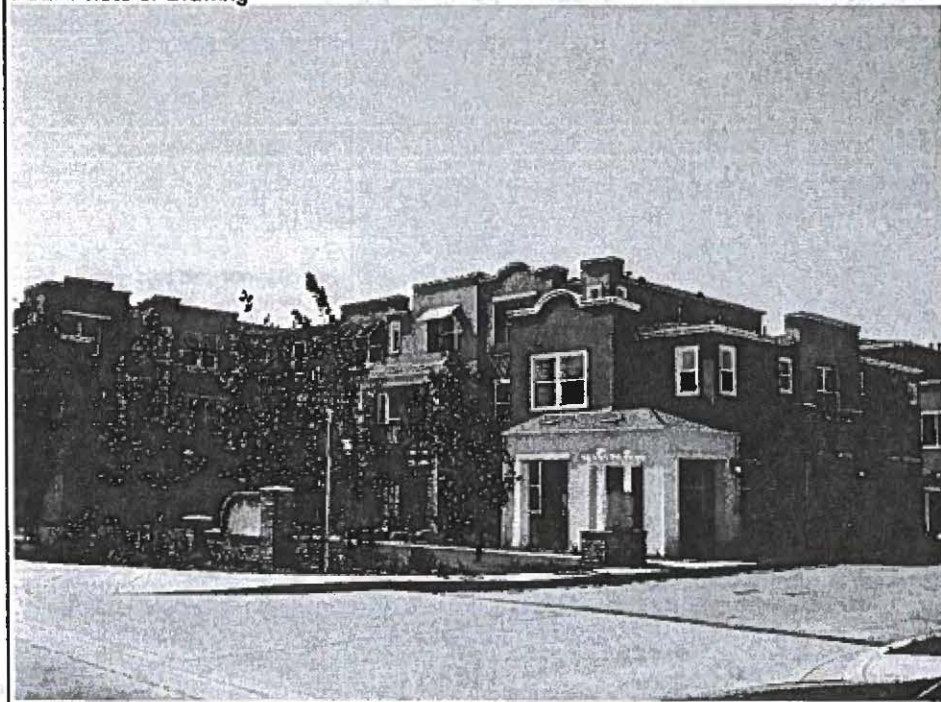
P5a. Photo or Drawing

P5b. Description of Photo:
 View W (10/5/06)
